PHOTO LOG**W 13008**

Wesco/Lander field

SPCC Inspection 6 June 2013

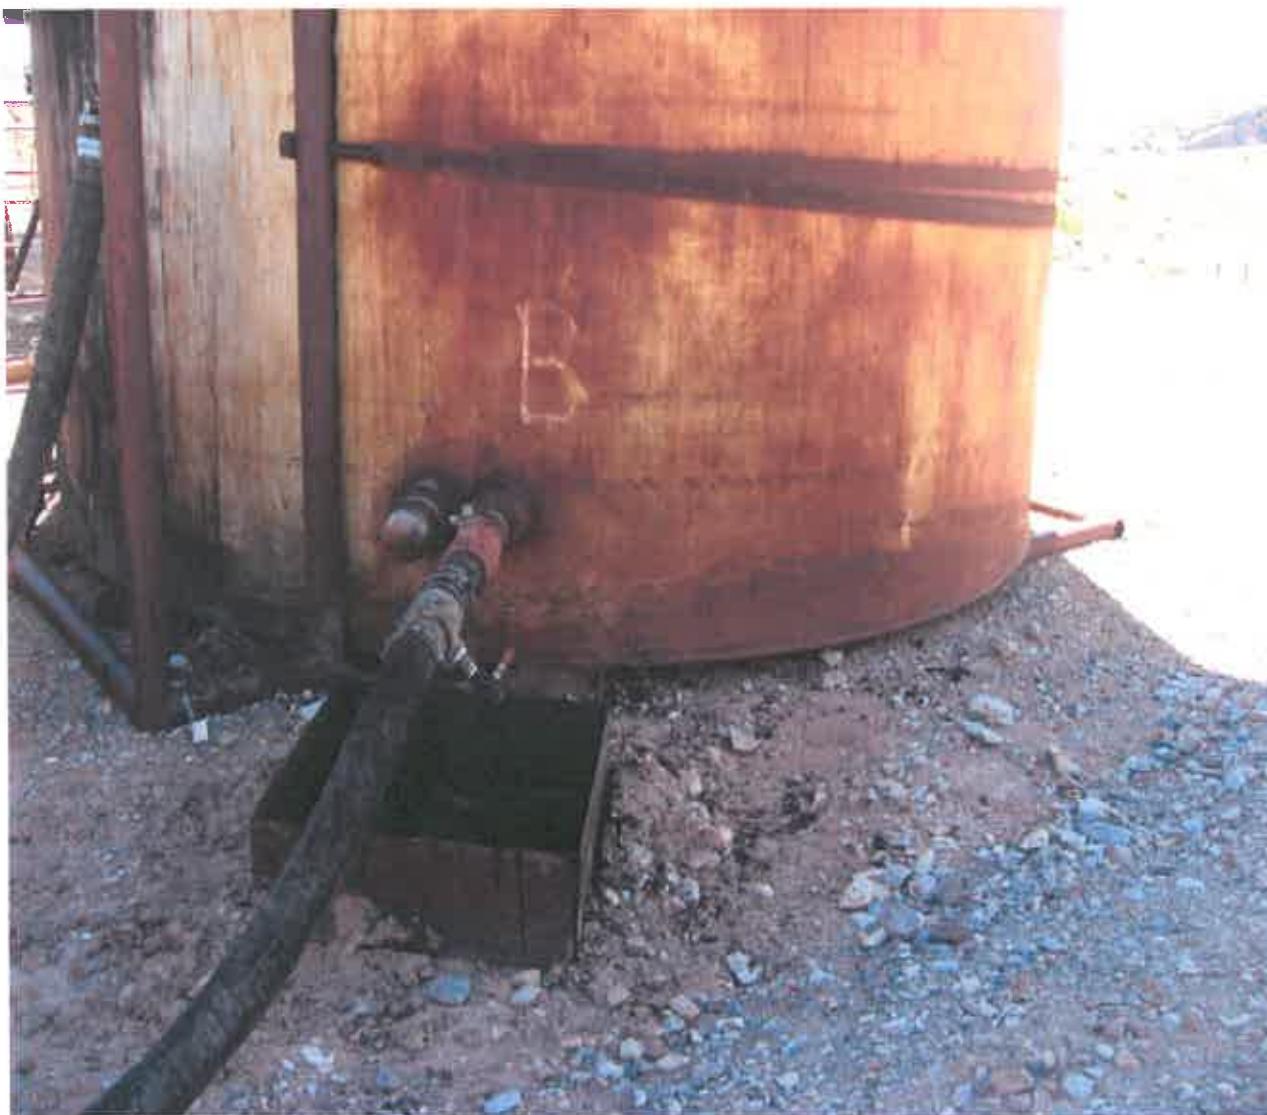
35: Base of 400 bbl frac tank, with oil access valve and hose, drip pan.

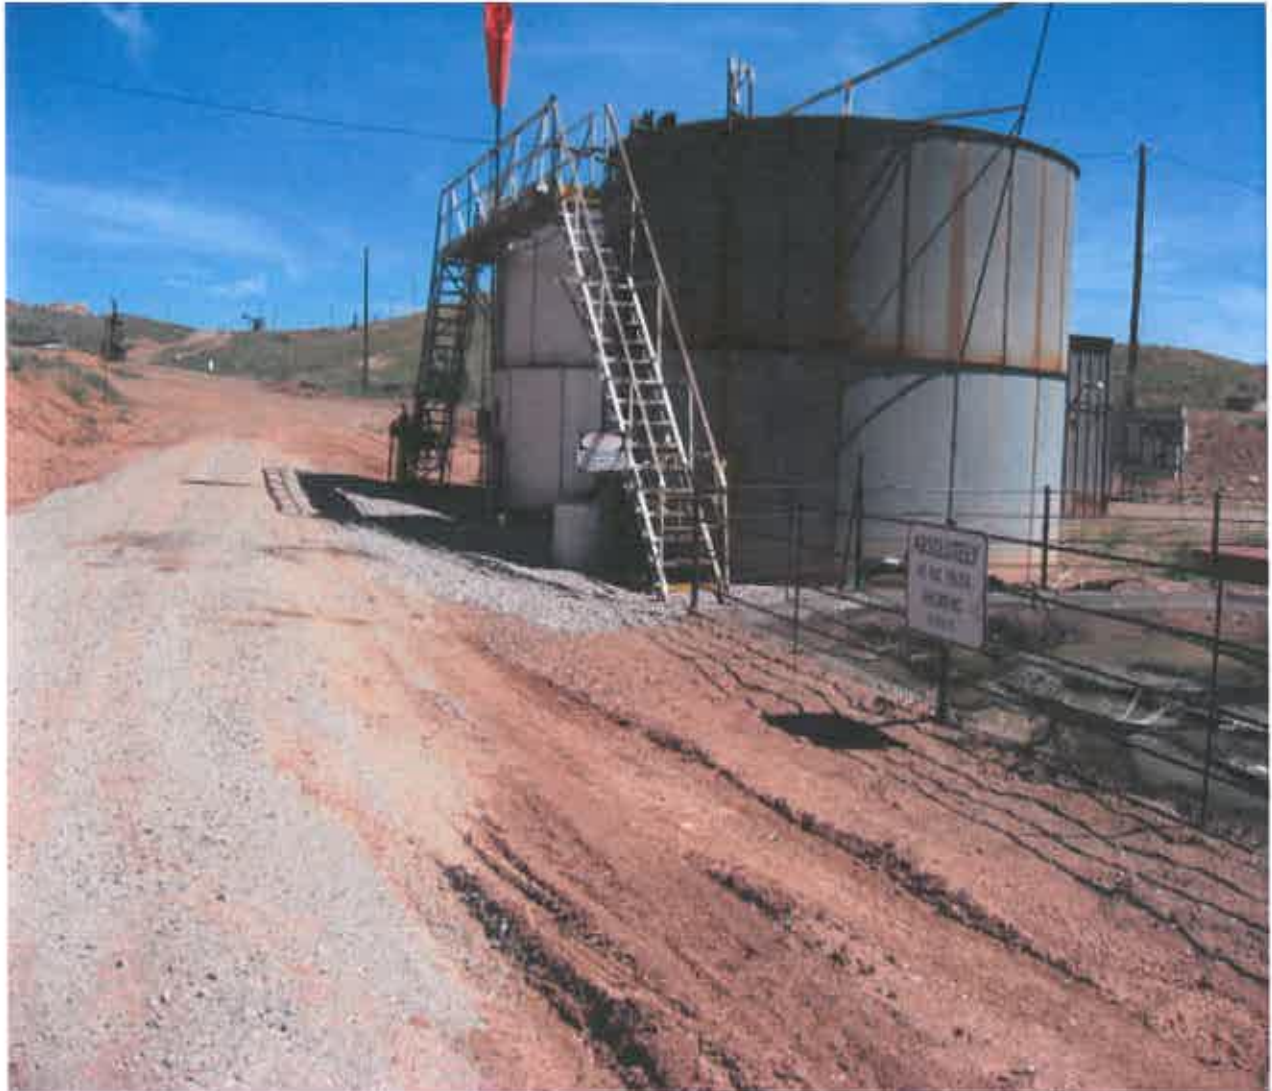
36: Two X 1000 bbl field constructed water tanks, SB (steel bolted) just north of concrete pit for evaporation/storage process to recycle oils. Note fencing, screen over pit area and sign warning against any truck unloading into pit.
